SUBJECT: Management Alert – Safety Concern at a U.S. Postal
Service Facility (Report Number HR-MT-16-001)

This management alert presents a safety concern of the methane detection system observed at the U.S. Postal Service Michigan Metroplex Processing and Distribution Center (Metroplex), located in Pontiac, MI (Project Number 16RG002HR001). This review was initiated based on safety concerns expressed to us in a complaint which identified five employee deaths during a 14 month period (16RG002HR000). We have not correlated these deaths to the safety concern at this time, but are continuing work in this area. However, we are reporting this issue with the methane detection system for your immediate action.

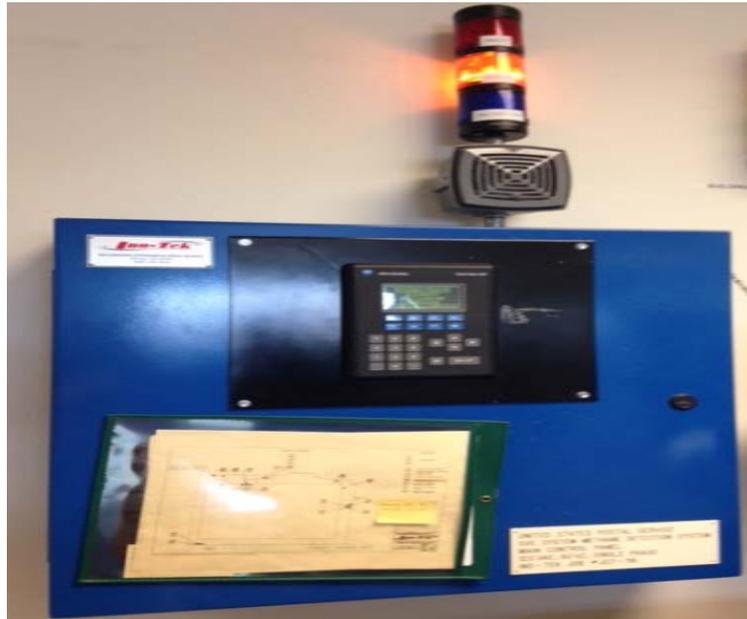
Figure 1 – Methane Detection System Main Control Panel

Based on our observations and review of the MDS log book, the methane detection system has not functioned properly since March 2015. Maintenance personnel documented in the log book attached to the MDS that 10 warnings (amber light flashings) occurred between March and July 2015. The LEL percentages, when annotated on the log book, ranged between 6 to 18 percent. According to the log book, the sensor was replaced in March 2015. A vendor's invoice totaling over \$2,000 shows that the vendor replaced the same sensor and recalibrated the system in September 2015, 6 months later. The vendor also provided maintenance personnel three sensors so that they could replace the sensors themselves.

In addition, we observed the amber light flashing on the main control panel on October 21, 2015, while the panel showed an LEL of 0 percent (see [Figure 1](#)). The panel indicated the warning level was cleared and the system could be reset. However, if the system was operating as designed, during our observation, the blue indicator light, which is designed to flash when there is a sensor malfunction, would have been illuminated. Additionally, the amber light flashed when the screen on the main control panel showed 0 percent LEL, which further indicates that the system was not functioning properly.

When we asked maintenance personnel about the amber flashing light, we were told that the sensor was malfunctioning and personnel were waiting for the vendor to provide parts. To support their comment, they provided documentation of an invoice showing the recent replacement of the sensor and recalibration of the system on September 14, 2015. However, there was no indication on the invoice showing that the vendor concluded:

1. Complete a review of the methane detection system to resolve any issues.
2. Establish an ongoing process to independently validate the results of the methane detection system on a periodic basis.
