Office of Inspector General | United States Postal Service

# Postal Service's Heating, Ventilation, and Air Conditioning Preventive Maintenance Process

Report Number SM-AR-19-006 | August 22, 2019

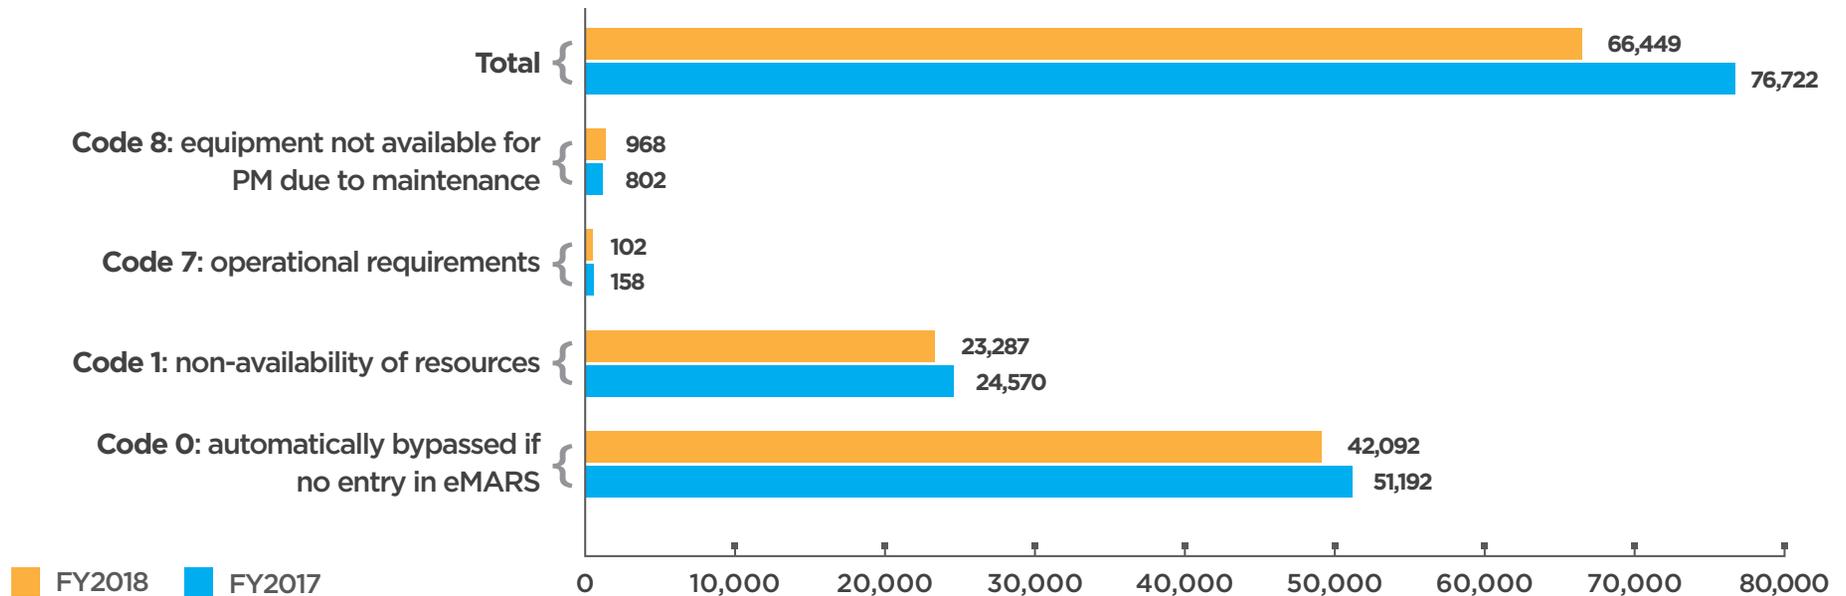
**Figure 1. Incomplete Scheduled HVAC PM Routes**

Bypass code 1 was the second most utilized code at 32 percent in FY 2017, and 35 percent in FY 2018, indicating resources were not available to perform the scheduled PM route. Figure 1 provides an overview of the frequency of bypass codes used to communicate why HVAC PM inspections were not conducted in FYs 2017 and 2018.
