## AUDIT REPORT

# Facility Condition Reviews – Greenfield, Maxwell, and New Palestine Post Offices

January 30, 2020

Report Number 20-071-R20

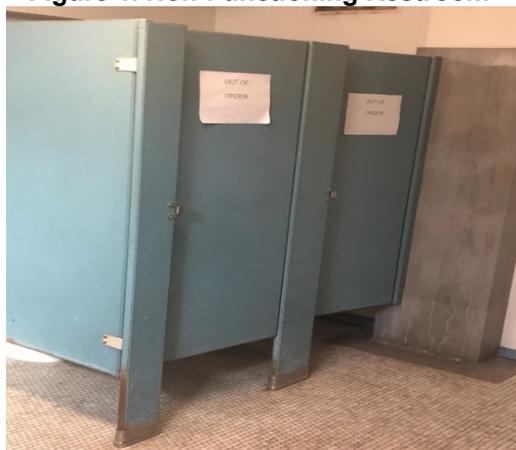
**Figure 1. Non-Functioning Restroom**

Due to an ongoing septic issue, the Greenfield Post Office has not had a fully functioning bathroom since November 2018 (see Figure 1). Instead, staff were required to use an outdoor portable restroom (see Figure 2). Management is aware of this issue and reported it in eFMS in November 2018, December 2018, and January 2019. A plumbing company assessed the issue and provided an estimate to make the repairs. However, due to the severity of the problem (including collapsed sewer lines), the extent of repairs needed, and potential costs involved, the Postal Service requested a price proposal from an architectural and engineering firm in January 2019 and awarded the work order in March 2019. The Postal Service issued a work order modification in September 2019. As of the date of this report, the work has not been completed.

The Greenfield Post Office sewer repairs are a long term project that will be completed in stages. Contractors responsible for the repairs have met with the postmaster and have provided a timeline for completion for the initial stage for five weeks. Once completed they will meet again to update postmaster an updated completion date with target completion of March 31, 2020. Gashes in the wall will be completed by BMC in spring, broken ceiling fan was removed and is no longer needed, excess supplies and equipment stored outside have been removed to the extent possible and basement clutter will be completed by February 29, 2020. Electrical outlet hanging from ceiling was tied up out of way (former desk location). Outside painting of handrails, inspection door repair and paint, lobby painting, crumbling concrete on loading dock and cracked window replacement will be completed by FMO when weather permits with target completion by March 31, 2020.

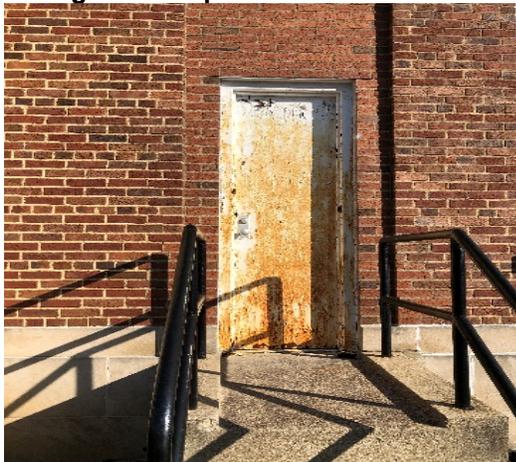
**Figure 3. Inspection Service Door**

Several areas throughout the Greenfield Post Office needed painting. Specifically, the outside Inspection Service access door was rusted (see Figure 3) and handrails were chipped (see Figure 4). Inside, the walls in the lobby were dirty and needed paint. Some of the same deficiencies were previously identified at the Greenfield Post Office during

our 2016 review of facility conditions in the Great Lakes Area and were also reported in eFMS.

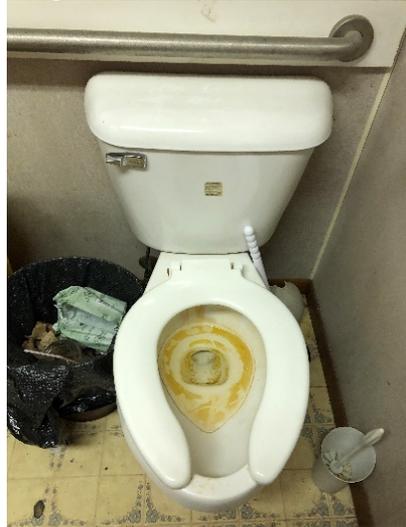
**Figure 5. Dirty Restroom at the Maxwell Post Office**

At the Maxwell Post Office, the restroom was dirty and served as a storage closet (see [Figure 5](#)). Both the inside and outside of the facility, including the main entrance door, needed repair. Specifically, there was rotted wood on the side of the building (facing the parking lot), chipped cement around the windows, and the entire building (internally and externally) needs painting. Lastly, the mailbox near the front door was severely dented, rusted, dirty, and in need of repair.

The Maxwell Post Office restroom has been cleaned and excess supplies removed to the extent possible on October 29, 2019. Regular cleaning will be completed. FSSP has contacted the landlord for main office door, rotten exterior wood, chipped concrete around windows, interior and exterior painting with repairs scheduled to be completed by spring. Mailbox replacement has been ordered and will be installed once received by FMO and is expected by February 28, 2020. Floor unevenness due to transition from old to new structure and no further repair or modification possible.

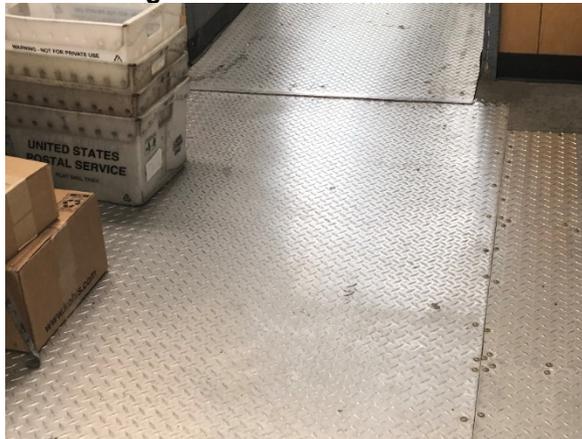
**Figure 6. Rural Carrier Floor**

At the Greenfield Post Office, sections of the rural carrier floor were buckling and had metal plates causing a trip hazard (see Figure 6). In our 2016 Great Lakes Area audit, we identified a missing section of the rural carrier floor. Management installed sections of metal plates to address the issue; however, the metal plates flex and are uneven.

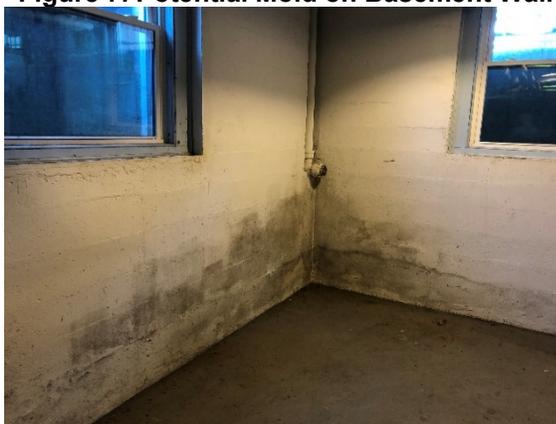
**Figure 7. Potential Mold on Basement Wall**

- An electrical outlet hanging from the ceiling and frayed internet cables were not secured on the workroom floor.
- One fire extinguisher missing a monthly inspection and one missing an annual inspection.
- A section of the wall in the basement was covered in a substance that appeared to be potential mold (see Figure 7).

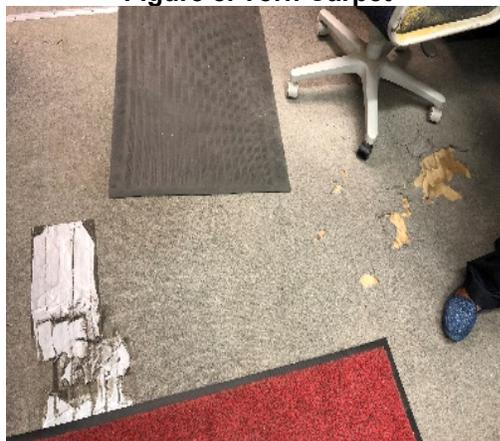
**Figure 8. Torn Carpet**

At the Maxwell Post Office, one fire extinguisher was missing both annual and monthly inspections, the floor was uneven, and sections of the carpet were torn, causing a tripping hazard (see Figure 8).

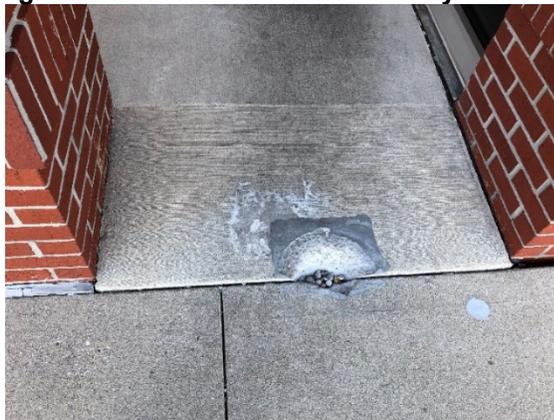
**Figure 9. Broken Concrete at Facility Entrance**

At the New Palestine Post Office, the drainage valve in the women's restroom handicap stall was uneven and a potential trip hazard. The only smoke detector in the facility was not working and, instead of having it fixed or replaced, it was disconnected. Lastly, there were cracks and potholes throughout the customer parking lot and along the entry to the

facility (see Figure 9). This was previously reported in eFMS in April 2018, February 2019, and September 2019, and remained an issue at the time of our review.
