# OFFICE OF INSPECTOR GENERAL

### Facility Condition Reviews – Pacific Area

#### Audit Report

Report Number  
**SM-AR-17-007**

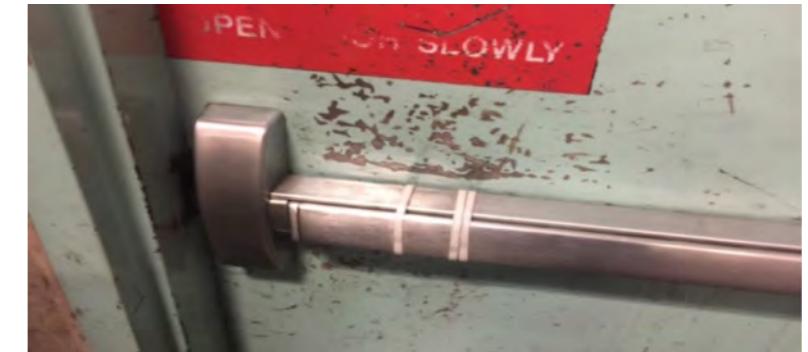
**Figure 1. Altered Locking Mechanism on Exit Door**

- Three (5 percent) did not prevent public access to employee work areas that should have been secured. The rear outside doors of the three facilities, as well as an inside lobby door of one of the facilities, were unlocked and not monitored, allowing unrestricted access.
- Two (4 percent) had unlocked inspection service lookout gallery doors, which are required to be locked.
- One (2 percent) had a customer access door with a broken lock that required a screwdriver to secure the building at night.
- One (2 percent) had an unfastened wire security mesh above the customer service window, allowing access to the employee work area.
- One (2 percent) had six USPS vehicles that were unlocked and unattended.
- One (2 percent) had the metal latch bar on an exit door altered to disable the automatic locking mechanism, allowing unrestricted access (see Figure 1).

Source: OIG photograph taken October 27, 2016, Santa Clarita Plant and Distribution Center, Santa Clarita, CA.

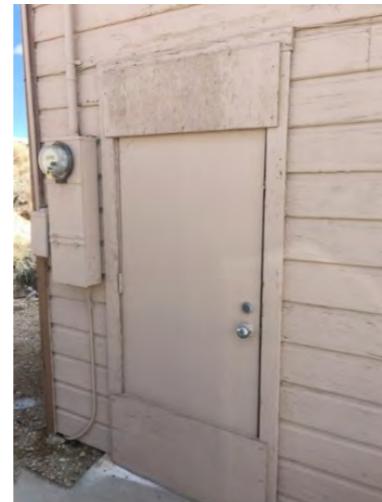
**Figure 3. Side Exit Door Nailed Shut**

- Four (22 percent)<sup>9</sup> had blocked emergency exits or exits that were not properly marked. One leased facility's side door was nailed shut, preventing its use as an exit during an emergency (see Figure 3). This deficiency was reported in the eFMS in June 2016 with an urgent status; however, the lessor had not responded to the repair request. Subsequent to the OIG site visit in February 2017, management took appropriate action with the lessor and repaired the door in April 2017.

Source: OIG photograph taken February 28, 2017, Darwin Main Office, Darwin, CA.

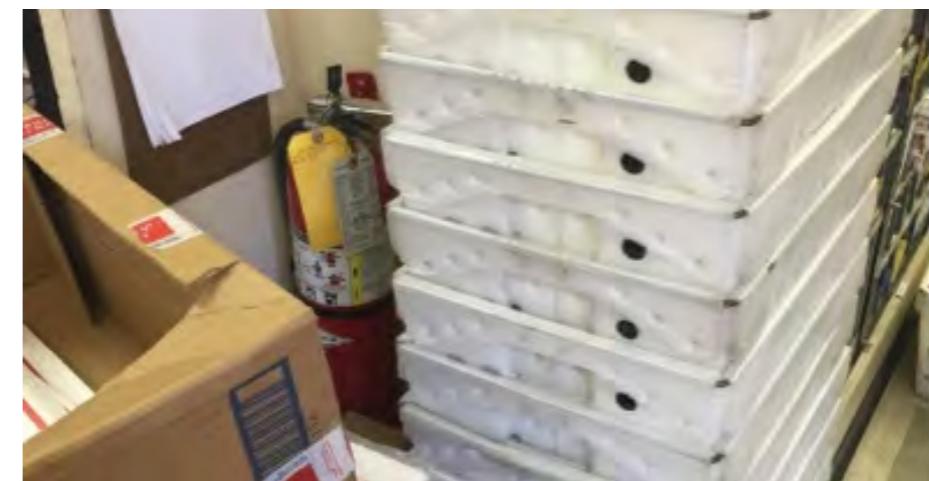
**Figure 2. Blocked Access to Fire Extinguisher**

- Thirteen (23 percent) had lighting issues such as bulbs needing replacement or inoperable light fixtures.
- Twelve (67 percent)<sup>7</sup> had fire extinguishers that were not inspected either monthly or annually as required.<sup>8</sup> One facility had a fire extinguisher that had not been inspected since 2001 and another had blocked access to the fire extinguisher (see Figure 2).

Source: OIG photograph taken March 1, 2017, Summerland Main Office, Summerland, CA.

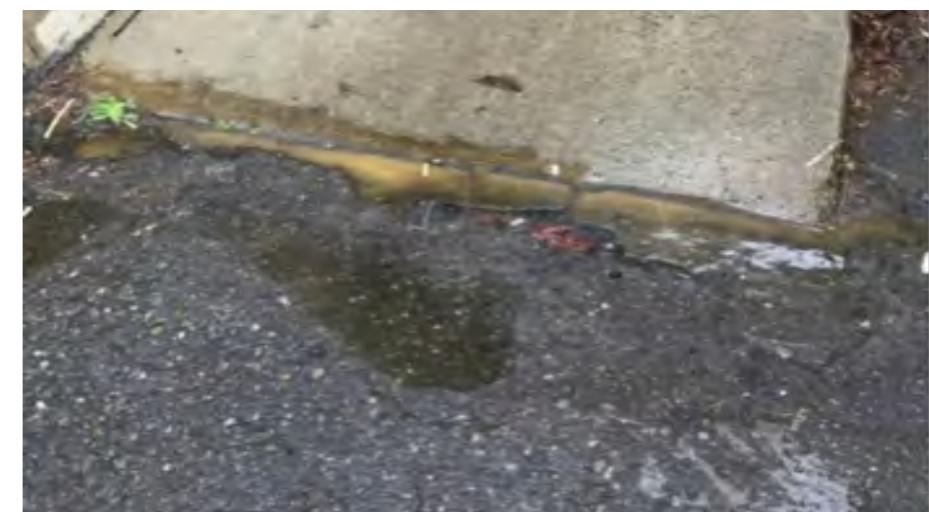
**Figure 4. Potential Tripping Hazard on Uneven Ramp Surface**

- Three (5 percent) had potential tripping hazards. Two of the facilities had uncovered electrical cords and wires in workroom paths. Another facility had damaged flooring and an uneven ramp surface used daily by carriers loading their vehicles (see Figure 4).

Source: OIG photograph taken March 22, 2017, Olivehurst Main Office, Olivehurst, CA.

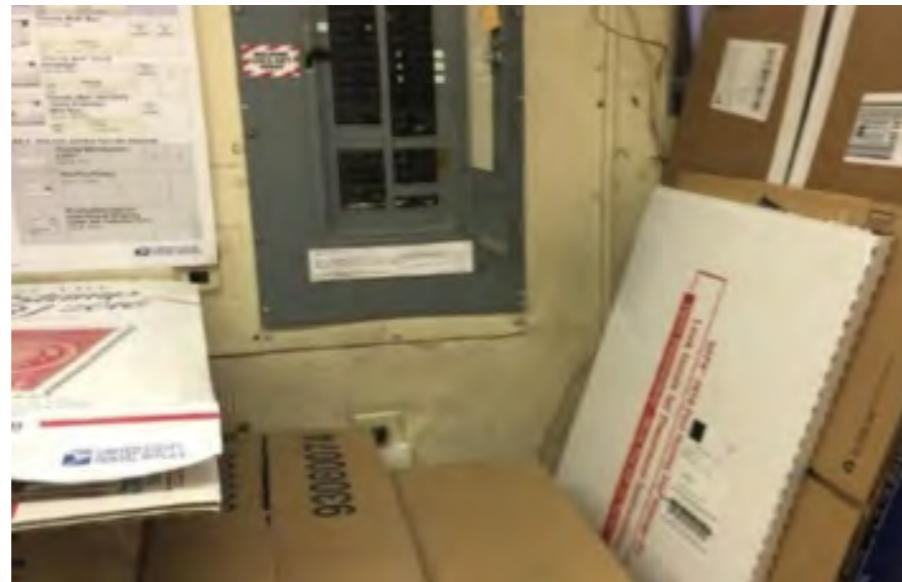
**Figure 5. Blocked Electrical Panel**

- Three (5 percent) had exposed wires or blocked electrical panels (see Figure 5).
- Two (4 percent) had sanitary issues such as poorly maintained bathrooms, one of which contained disposable razors placed near a sink. Another contained excess restroom fixtures, including disconnected hoses, sinks, and toilets (see Figure 6).

Source: OIG photograph taken March 1, 2017, Summerland Main Office, Summerland, CA.

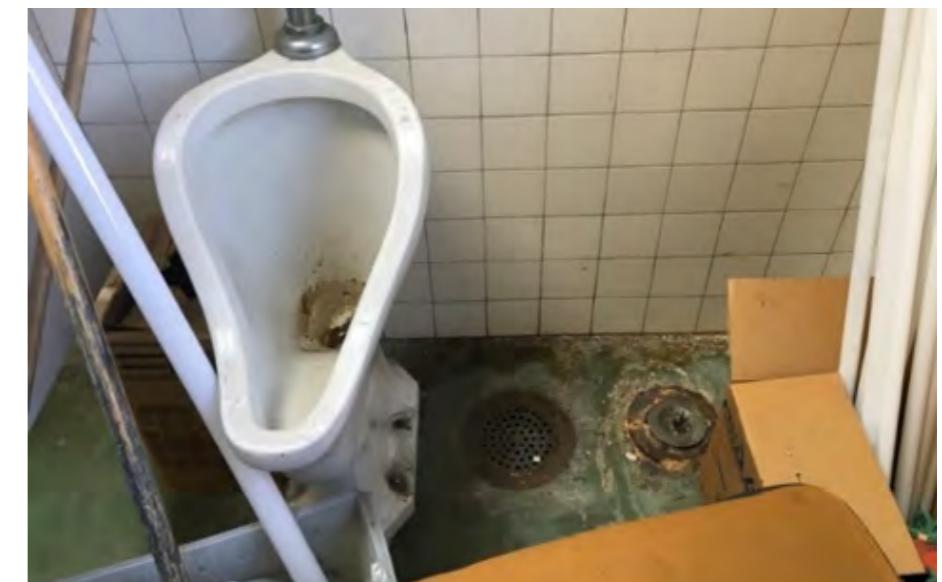
**Figure 6. Excess Disconnected Restroom Fixtures**

Source: OIG photograph taken March 30, 2017, Webster Street Station, Alameda, CA.

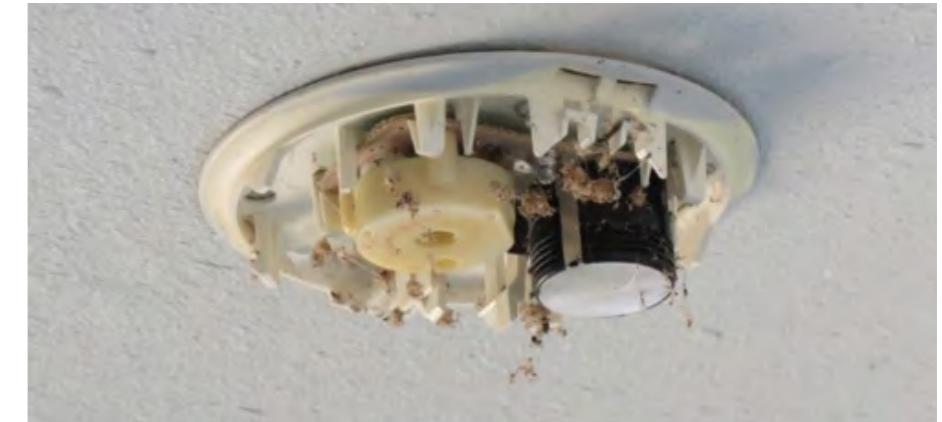
**Figure 8. Inoperable Smoke Detector**

- Two (4 percent) had potential mold or asbestos exposure, including a facility with an entire wall containing an unknown substance that appeared to be mold (see Figure 7).
- One (2 percent) had a mounted smoke detector in the customer lobby with its cover and battery removed, rendering it inoperable (see Figure 8).

Source: OIG photograph taken March 28, 2017, Phillipsville Main Office, Phillipsville, CA.

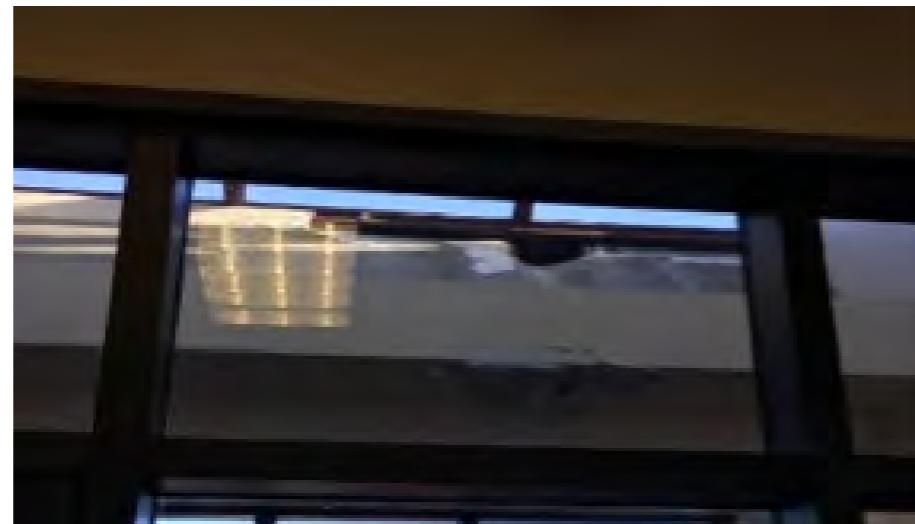
**Figure 9. Damaged Ceiling Panel Above Customer Entrance**

- Twenty-five (45 percent) needed repair and maintenance of ceilings, walls, and floors. Some facilities had cracked or missing floor tiles; water-stained, damaged or missing ceiling tiles; and others needed fresh paint and repair to interior walls, exterior siding, and trim. One facility had damaged ceiling panels and the interior wall directly above the main customer entrance (see [Figure 9](#)).
- Nine (16 percent) had landscaping issues such as overgrown grass, shrubs, and trees and dead shrubs and barren grass areas; and one facility did not remove excess equipment from the property (see [Figure 10](#)).

Source: OIG photograph taken March 21, 2017, Suisun City Main Office, Suisun City, CA.

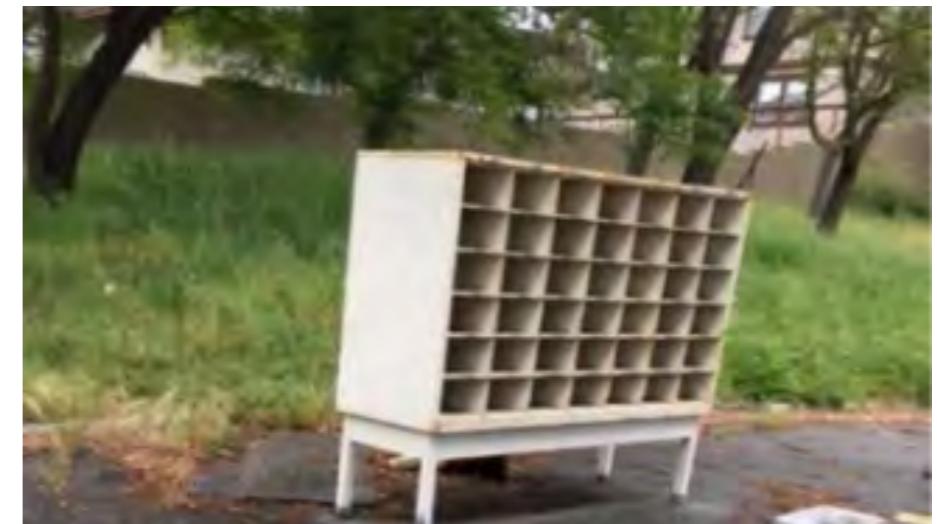
**Figure 10. Excess Equipment Not Removed from Property**

Source: OIG photograph taken April 12, 2017, Danville Main Office, Danville, CA.

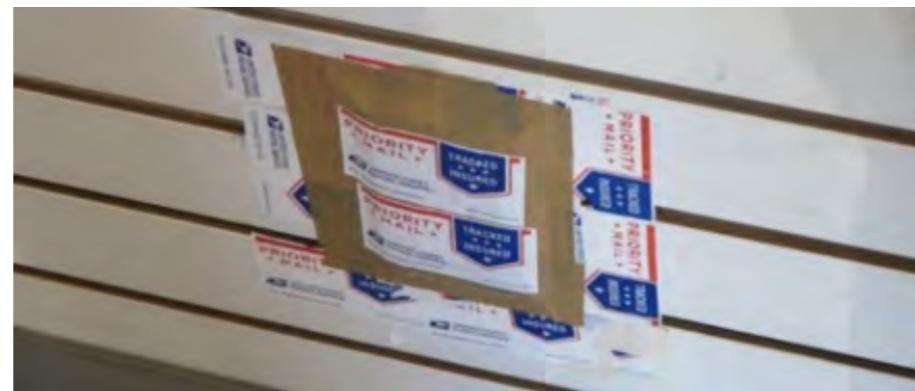
**Figure 11. Electrical Outlets in Lobby Covered with USPS Packing Products**

- Eight (14 percent) had unappealing lobbies with issues such as dirty screens and cracked glass windows; damaged tables, counter tops, and walls; broken parcel lockers and post office boxes; a customer entrance walkway littered with tree droppings; and lobbies that appeared dark and gloomy. One facility had Priority Mail® packaging materials taped over the electrical outlets throughout the lobby (see Figure 11).

Source: OIG photograph taken February 23, 2017, Goldenwest Station, Westminster, CA.

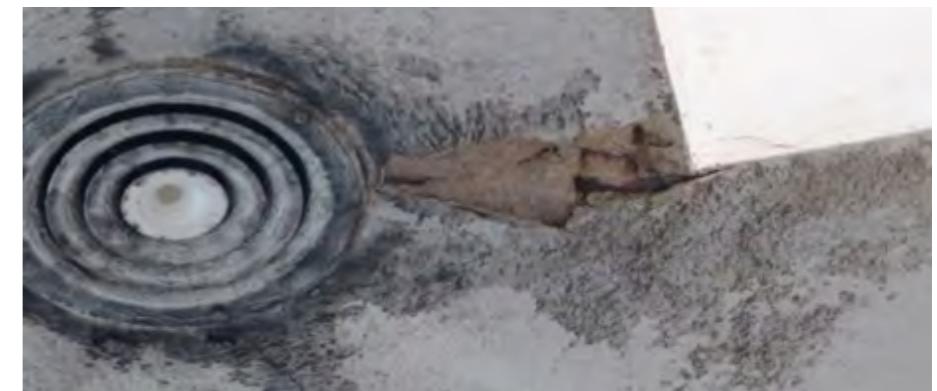
**Figure 12. Unsanitary Air Vents**

- Eight (14 percent) had interior maintenance issues such as restrooms with leaking faucets and a missing stall door; an exit door that allowed rain water to seep into the facility due to a damaged weather seal; and customer and employee work areas containing dirty skylights and unsanitary air vents (see Figure 12).

Source: OIG photograph taken March 30, 2017, Webster Street Station, Alameda, CA.

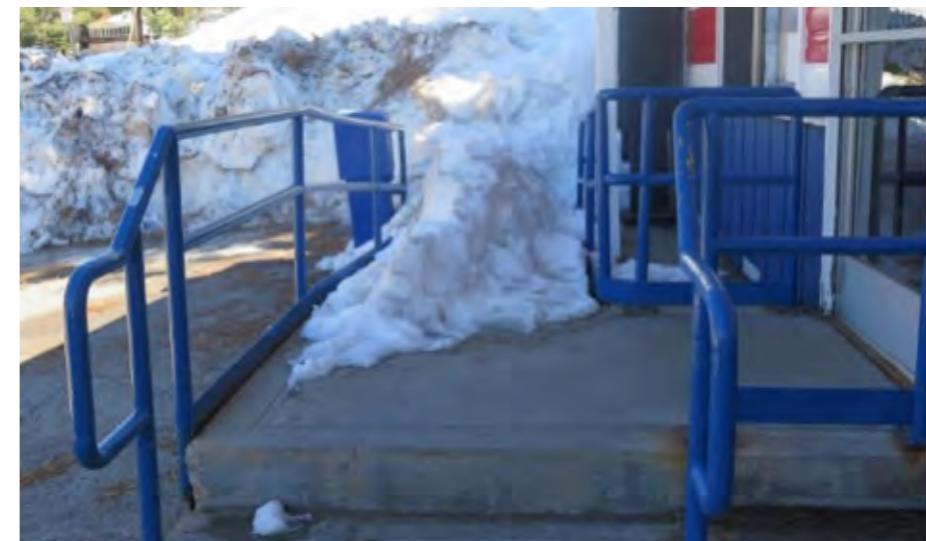
**Figure 13. Obstruction of Handicap Accessible Ramp**

- Two automatic door opener controls for handicap access were not functioning due to expired batteries.
- One handicap ramp was inaccessible due to the placement of plowed snow from the parking lot (see Figure 13).

Source: OIG photograph taken February 22, 2017, Running Springs-Green Valley Lake Br, Green Valley Lake, CA.
