Office of Inspector General | United States Postal Service

Audit Report

Capital Metro Physical and Environmental Controls Site Security Review

Report Number IT-AR-18-005 | September 28, 2018

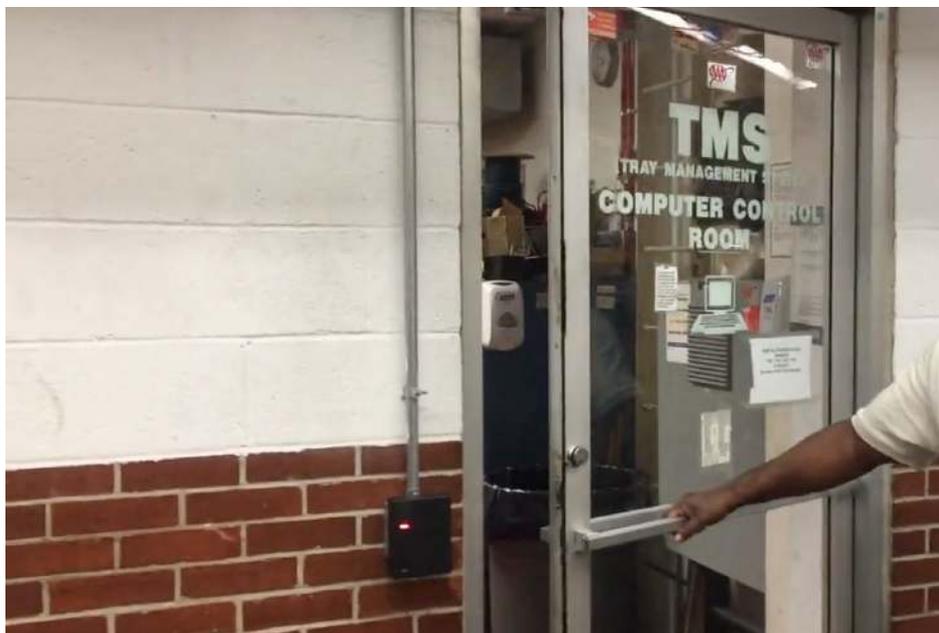
Figure 1: TMS Server Room Door

During our site visit, we found that the entrance door to the TMS server room did not lock and 70 Internet Protocol (IP) addresses⁸ were posted on equipment and a server room wall. Video 1 shows the TMS server room door not locking. Postal Service policy states physical and administrative security controls must be

implemented at each facility to protect against unauthorized personnel access and to protect the physical integrity of Postal Service information resources located at the facility.⁹

These issues occurred because facility management was not aware that the lock on the server room door was broken and there were risks associated with displaying IP addresses in the server room. When the Postal Service does not implement proper physical security controls, there is an increased risk of unauthorized access to TMS servers that control flat sorting, parcel sorting, and mail tray transport throughout the [REDACTED] P&DC.

The [REDACTED] District Manager replace the lock on the Tray Management System (TMS) server room entrance door and make sure that it functions properly, and remove all posted Internet Protocol addresses from the TMS server room.

Regarding recommendation 2, management agreed to repair and verify that the lock for the server room is working properly and stated they have removed the IP addresses in the server room. The target implementation date is September 30, 2018.

Management agrees with this recommendation and has implemented by already removing the IP addresses and the lock has been repaired and verified to be operating properly.

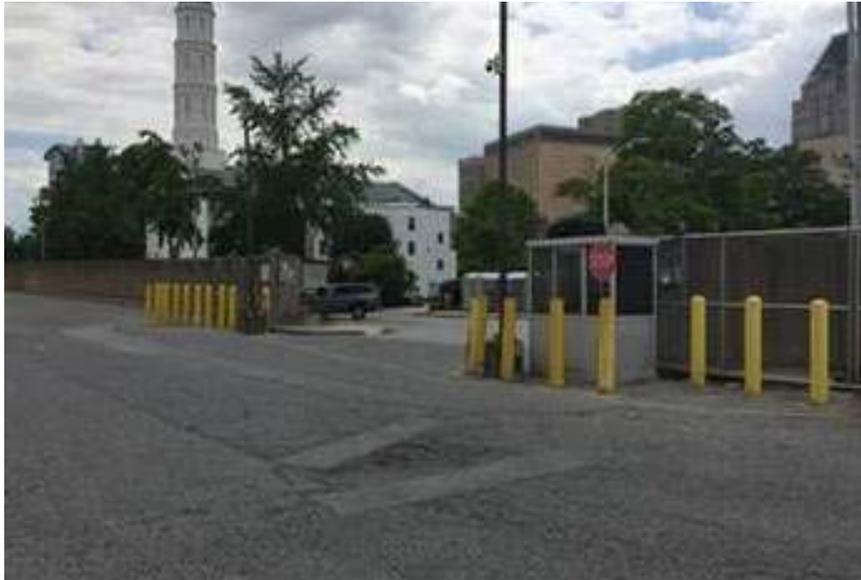
Figure 2. East Vehicle Entrance Gate

During our site visit, we observed physical access controls that allowed unauthorized access to the facility and critical assets. Specifically, we found weaknesses in the following areas:

- Vehicle Entrance Gates.** The east and west vehicle entrance gates remained open 24/7 without being monitored; and did not have traffic arms, computerized card access systems, intercoms, or functioning closed-circuit television (CCTV)¹⁰ cameras as shown in the east and west vehicle entrance gate photos below. This allows unauthorized individuals to enter the facility through the loading docks gaining access to the facility, workroom floors, and the server rooms.¹¹ Postal Service policy states that facility entrance gates should have traffic arms, computerized card access systems, intercoms, and CCTV cameras.¹²

This occurred due to a lack of management oversight of the physical security at the facility and an enforcement of policy. Management stated that budget constraints prevented them from installing traffic arms, card access systems, and intercoms at the entrance gates. In addition, the entrance door locks were broken, and a badge access reader was not working; and they did not enforce the policy requiring employees to wear ID badges while at the facility. In the retail area, management did not contract to install the eight CCTV cameras that were purchased over a year ago.

The [REDACTED] **District Manager** ensure entrance gates are monitored and have traffic arms, computerized card access systems, and intercoms are installed at the entrance gates.

Regarding recommendation 3, management did not agree to monitor entrance gates, install traffic arms and intercoms, and grant computerized card access. Management has also requested that we close this recommendation because they have deemed it physically infeasible to install the equipment required. There is no target implementation date.

Regarding recommendation 3, management stated that an architectural engineering firm found the requirements outlined in our recommendation physically infeasible. For this recommendation to be officially closed, management should provide supporting documentation demonstrating that they have formally accepted the risk of noncompliance with Postal Service policy.

Management disagrees with this recommendation. The services of an architectural engineering firm were utilized to review existing site conditions to determine if access controls could be physically accommodated. Review of the existing site has found it physically infeasible to install the necessary equipment required as outlined in this recommendation. The current transportation needs and space constraints prohibit implementation and thus management requests closure of this recommendation.
