AUDIT REPORT

Facility Condition Reviews – Waynesville, Lake Junaluska, and Clyde Post Offices

Report Number 20-070-R20

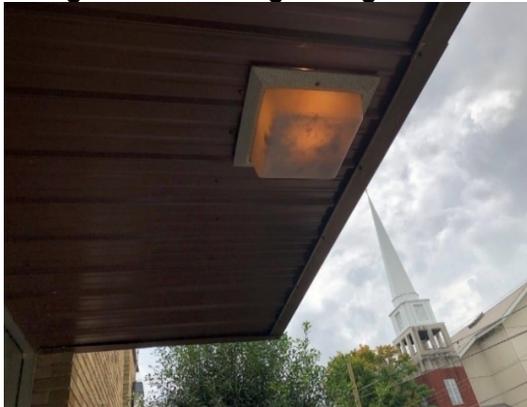
Figure 1. Dead Bugs In Light Fixture

At the Waynesville Post Office, we identified issues related to rusting, damaged walls, a missing ceiling tile, a damaged sidewalk, potholes, and other general maintenance issues. In addition, there were dead bugs in a light fixture and a rusted hand railing at the entrance to the building (see Figures 1 and 2).

Recommendation #1: We recommend the **Manager, Mid-Carolinas District**, address all building maintenance and safety issues identified at the Waynesville, Lake Junaluska, and Clyde Post Offices.

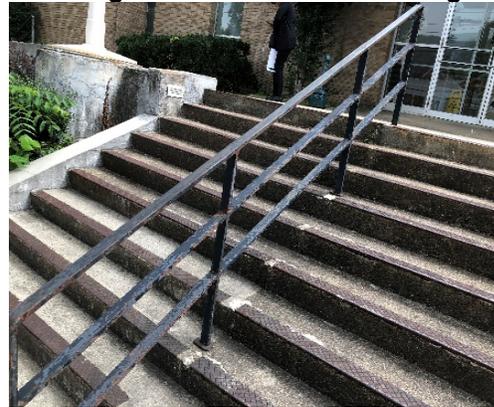
Figure 2. Rusted Hand Railing

| | Facility | Waynesville | Lake Junaluska | Clyde | Total Deficiencies |
|---|---|---|---|---|---|
| 4 | Rusted hand railing | D | D | D | 3 |

Regarding recommendation 1, management needs to address the remaining deficiencies such as rust removal on hand railings and parking lot paving and provide confirmation that the work has been completed.

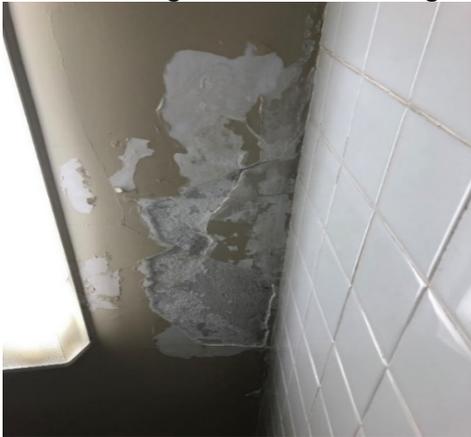
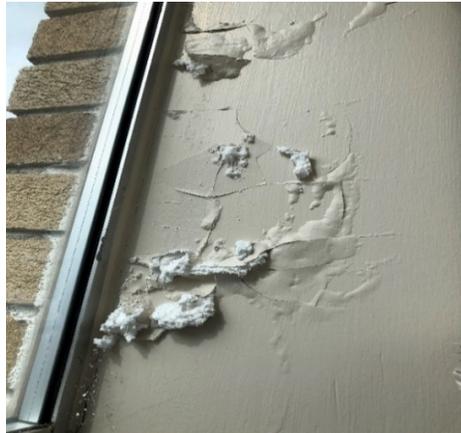
Figures 3 and 4. Damaged Plaster and Peeling Paint

In the lead clerk's office, we observed damaged plaster and peeling paint on the wall and window area caused by a previous water leak (see [Figures 3 and 4](#)). There was a missing ceiling tile in the same office (see [Figure 5](#)).

| | Facility | Waynesville | Lake Junaluska | Clyde | Total Deficiencies |
|---|---|---|---|---|---|
| 1 | Damaged wall in the lead clerk's office | D | ✓ | ✓ | 1 |

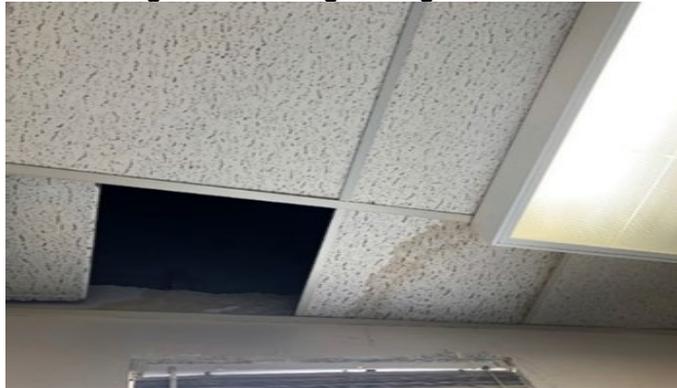
Figure 5. Missing Ceiling Tile

| | Facility | Waynesville | Lake Junaluska | Clyde | Total Deficiencies |
|---|---|---|---|---|---|
| 2 | Missing ceiling tile in the lead clerk's office | D | ✓ | ✓ | 1 |

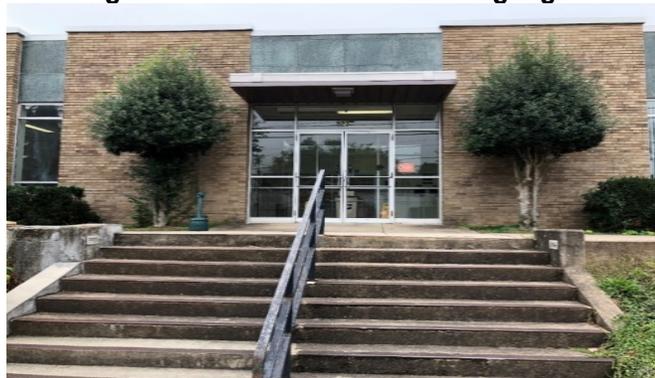
Figure 6. Covered Post Office Signage

There was overgrown shrubbery covering Waynesville Post Office signage, making it difficult for customers to identify the name of the facility (see Figure 6).

| | Facility | Waynesville | Lake Junaluska | Clyde | Total Deficiencies |
|---|---|---|---|---|---|
| 3 | Overgrown shrubbery covering the signage in front of building | D | ✓ | ✓ | 1 |

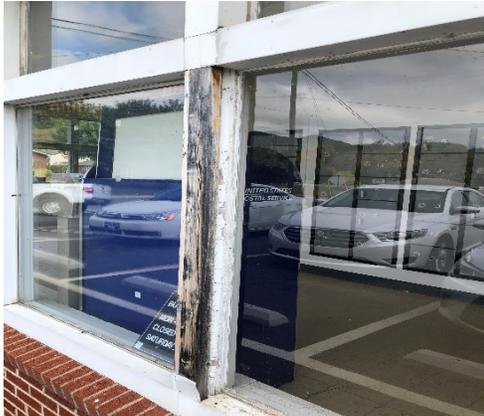
Figure 7. Damaged Window Board

At the Lake Junaluska Post Office, there was a damaged window board at the entrance and a rusted and leaning fence in the customer parking lot area (see Figures 7 and 8).

| | Facility | Waynesville | Lake Junaluska | Clyde | Total Deficiencies |
|---|---|---|---|---|---|
| 6 | Damaged window board near the entrance of the facility | ✓ | D | ✓ | 1 |

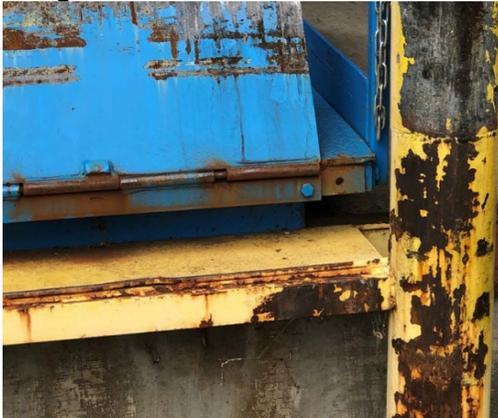
Figure 9. Rusted Protective Bollards

At the Clyde Post Office, there were rusted protective bollards in the loading dock area, a rusted backdoor (see Figures 9 and 10), a damaged sidewalk that could be a trip hazard, and potholes in the side parking lot (see [Figures 11](#) and [12](#)).

| | Facility | Waynesville | Lake Junaluska | Clyde | Total Deficiencies |
|---|---|---|---|---|---|
| 8 | Rusted protective bollards in the loading dock area | ✓ | ✓ | D | 1 |

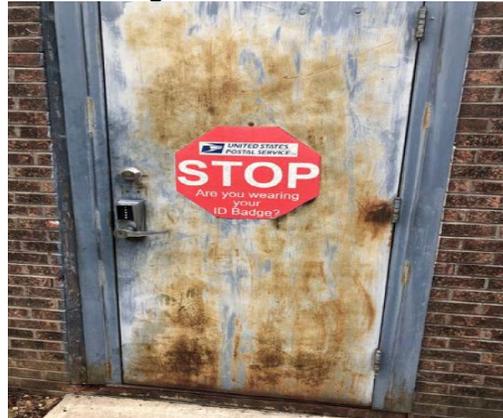
Figure 10. Rusted Door

| | Facility | Waynesville | Lake Junaluska | Clyde | Total Deficiencies |
|---|---|---|---|---|---|
| 10 | Rusted door on the side of facility | ✓ | ✓ | D | 1 |

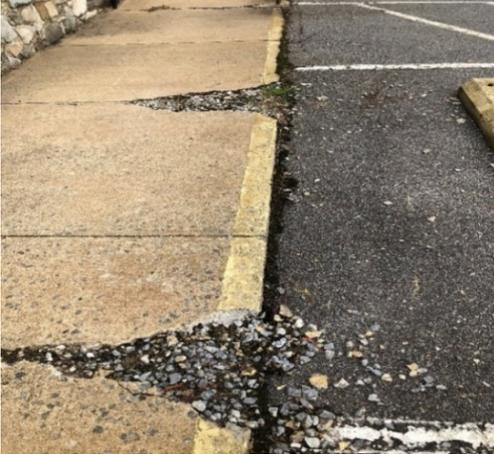
Figure 11. Damaged Sidewalk

| | Facility | Waynesville | Lake Junaluska | Clyde | Total Deficiencies |
|---|---|---|---|---|---|
| 9 | Damaged sidewalk that could cause a trip hazard | ✓ | ✓ | D | 1 |

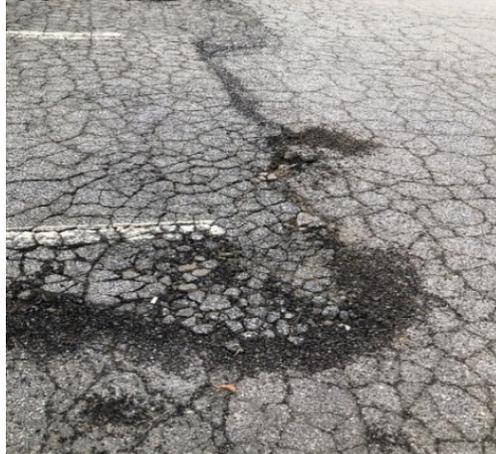
Figure 12. Potholes In Parking Lot

| | Facility | Waynesville | Lake Junaluska | Clyde | Total Deficiencies |
|---|---|---|---|---|---|
| 7 | Pothole in the customer parking area | ✓ | ✓ | D | 1 |

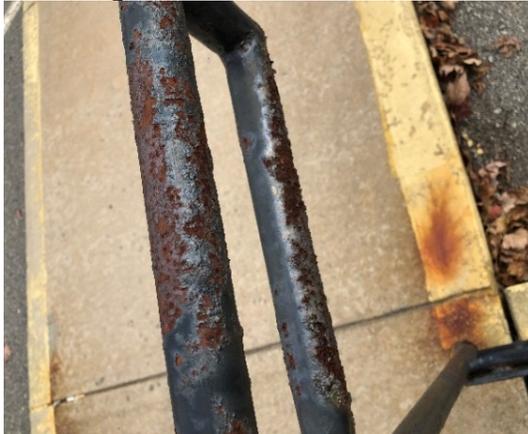
Figure 13. Rusted Hand Rail

In addition, the hand rail on the ramp to the Clyde Post Office was rusted and needed painting (see Figure 13) and the customer area had excessive dust on the light fixture (see Figure 14). The Clyde Post Office did not perform semiannual housekeeping inspections or maintain PS Forms 4851.

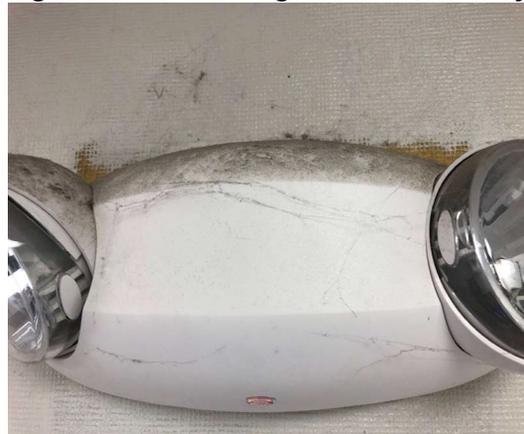
Figure 14. Dust On Light Fixture In Lobby

| | Facility | Waynesville | Lake Junaluska | Clyde | Total Deficiencies |
|---|---|---|---|---|---|
| 11 | Dust in the light fixture in the lobby area | ✓ | ✓ | D | 1 |

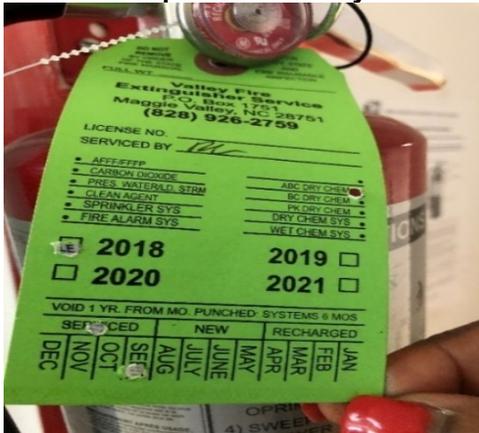
Figure 15. Fire Extinguisher Not Inspected Annually

At the Lake Junaluska Post Office, one fire extinguisher did not have an inspection tag showing that monthly and annual inspections were completed and another fire extinguisher did not have an annual inspection completed. The last inspection was performed in September 2018 (see [Figures 15](#) and [16](#)).

The Postal Service is required to maintain a safe environment for both employees and customers. In addition, OSHA requires employers to provide a safe and healthful workplace free of recognized hazards. More important, these issues could jeopardize the health, safety, and well-being of Postal Service employees and customers and could create an environment that dissuades customers from doing business in these offices. If management does not address hazards, the Postal Service could potentially incur fines. Conditions related to building maintenance and safety occurred due to management not prioritizing some issues and a lack of oversight. For example, some maintenance issues at the facilities were not considered priority and fire extinguisher inspections were not consistently completed at the Lake Junaluska Post Office. OSHA requires the inspection, maintenance and testing of all portable fire extinguishers, including monthly

and annual inspections.⁴ Management is also required to conduct housekeeping inspections semiannually,⁵ a requirement that local management at the Waynesville and Clyde Post Offices was unaware of.

| | Facility | Waynesville | Lake Junaluska | Clyde | Total Deficiencies |
|---|---|---|---|---|---|
| 15 | Portable fire extinguisher not inspected (monthly, annually) | ✓ | D | ✓ | 1 |

Recommendation #2: We recommend the **Manager, Mid-Carolinas District**, perform housekeeping inspections and ensure fire extinguishers are inspected monthly and annually at the Waynesville, Lake Junaluska, and Clyde Post Offices.

Regarding recommendation 2, management provided documentation of completed housekeeping inspections from December 2019 and updated fire extinguisher inspection tags. These actions were completed as of December 2019.

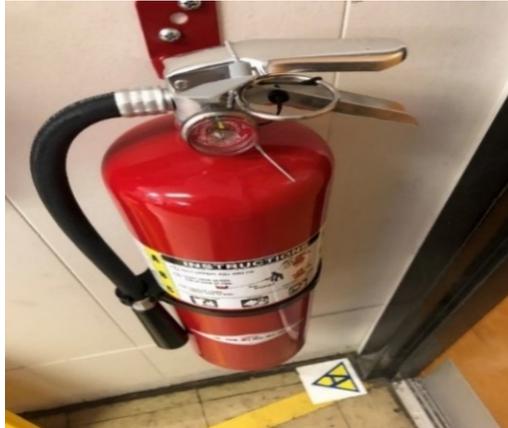
Figure 16. Fire Extinguisher With No Inspection Tag

| | Facility | Waynesville | Lake Junaluska | Clyde | Total Deficiencies |
|---|---|---|---|---|---|
| 16 | Portable fire extinguisher missing inspection tag to indicate if/when inspections were completed | ✓ | D | ✓ | 1 |

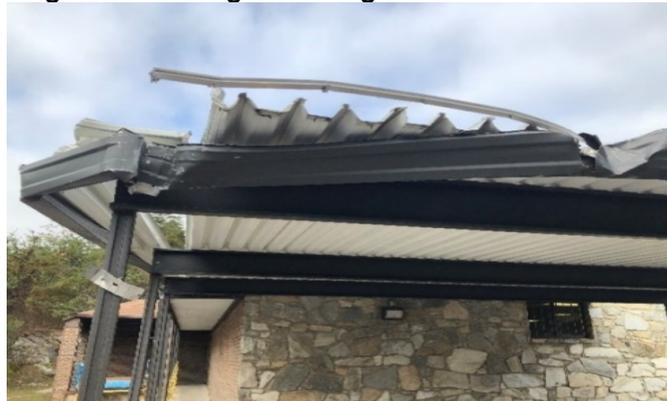
Figure 17. Damaged Awning at Back of Post Office

The Clyde Post Office had a damaged awning in the back of the facility. The Postmaster indicated that an Amazon truck hit the awning and weakened the base, posing a safety hazard if not replaced. The incident occurred on September 14, 2019 and was reported in eFMS on October 2, 2019. As of the date of this report, the work has not been completed (see Figure 17).

| | Facility | Waynesville | Lake Junaluska | Clyde | Total Deficiencies |
|---|---|---|---|---|---|
| 17 | Damaged awning at the back of facility | ✓ | ✓ | D | 1 |
