Office of Inspector General | United States Postal Service

Audit Report

Mail Delivery, Customer Service, and Property Conditions – Piedmont Station, Portland, OR

Report Number 22-030-R22 | February 2, 2022

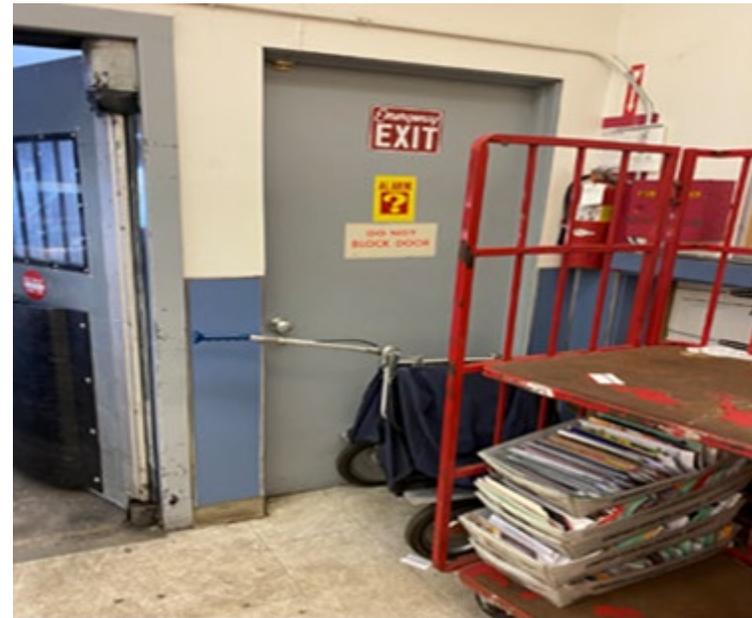
Figure 1. Blocked Emergency Exit and Door Extinguisher

We found safety and maintenance issues at the Piedmont Station including fire extinguishers that had not been inspected¹⁴ and which were not easily accessible. We also identified blocked exit route doors (see Figure 1 and Figure 2) and pieces of the ceiling missing in the loading dock area (see Figure 3).

Unit management did not take the necessary actions to ensure that property conditions issues were corrected because other duties took priority, such as addressing customer inquiries and ensuring carriers returned on time.

Management should have provided sufficient oversight to personnel responsible for maintaining facilities, reported safety and maintenance issues as they arose, and followed up for completion. The Postal Service is required to maintain a safe environment for employees and customers. In addition, OSHA requires employers to provide a safe and healthy workplace free of recognized hazards.¹⁵

Management has had all 6 fire extinguishers professionally serviced at a cost of \$146 and has begun monthly inspections. All items blocking the locations have also been removed. The piece of the missing ceiling is scheduled to be covered as one of the next projects by the owner as his next is repairing the entrance gate.
